Manhole Inspection Summary

Manhole # S29G__054MH

Insp Date: **8/4/08 11:42 AM**

Location Address: **630 fayette st**

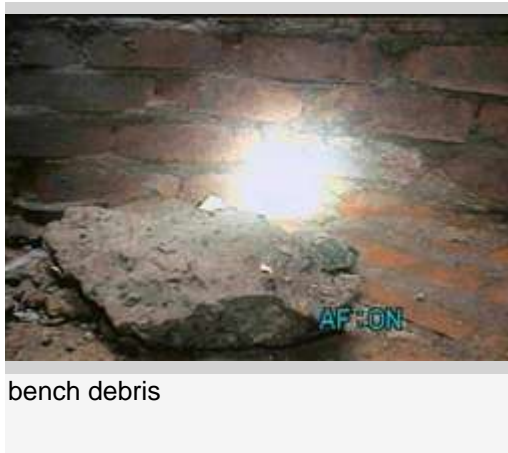
Miscellaneous

bench debris

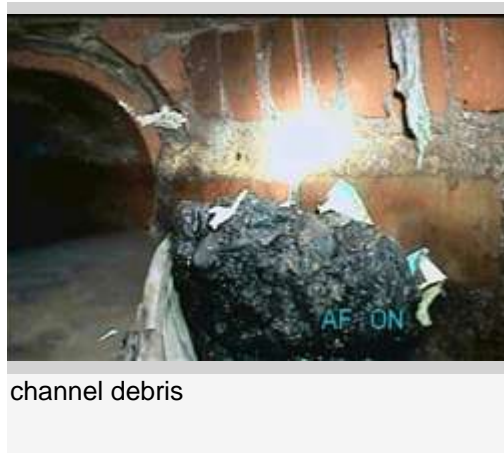
Miscellaneous

channel debris

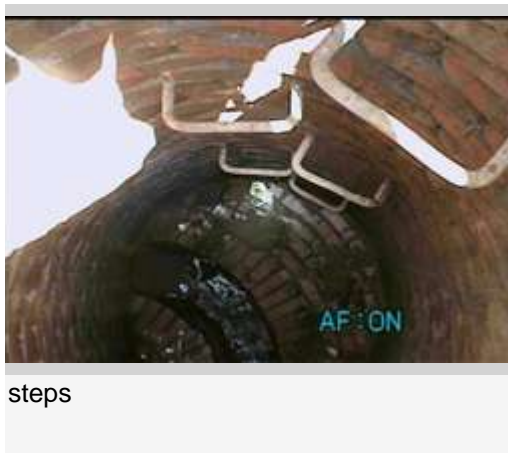
Defect 2

Steps Count: **5** Missing: **0** ☒ **Corroded**

steps

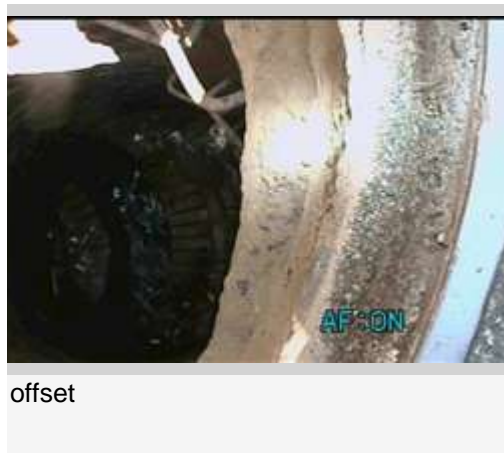
Defect 1

Frame Offset: **2** (in.) Condition: ☒ Sound ☐ Cracked ☐ Leaks

offset
